Village of Mount Kisco, NY Community Forest Management Plan | 2019

Submitted by: Bartlett Tree Experts

Village of Mount Kisco Community Forest Management Plan

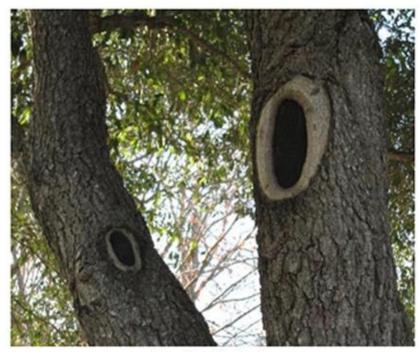
- Topping pruning cuts that reduce a tree's size by using heading cuts that shorten branches to a predetermined size. Topping substantially reduces the functional benefits a tree is capable of providing and predisposes trees to structural defects that can contribute to failures in the future. It also reduces the value of the trees substantially and deprives the tree of adequate foliage. See next page, top right.

Examples of topping.

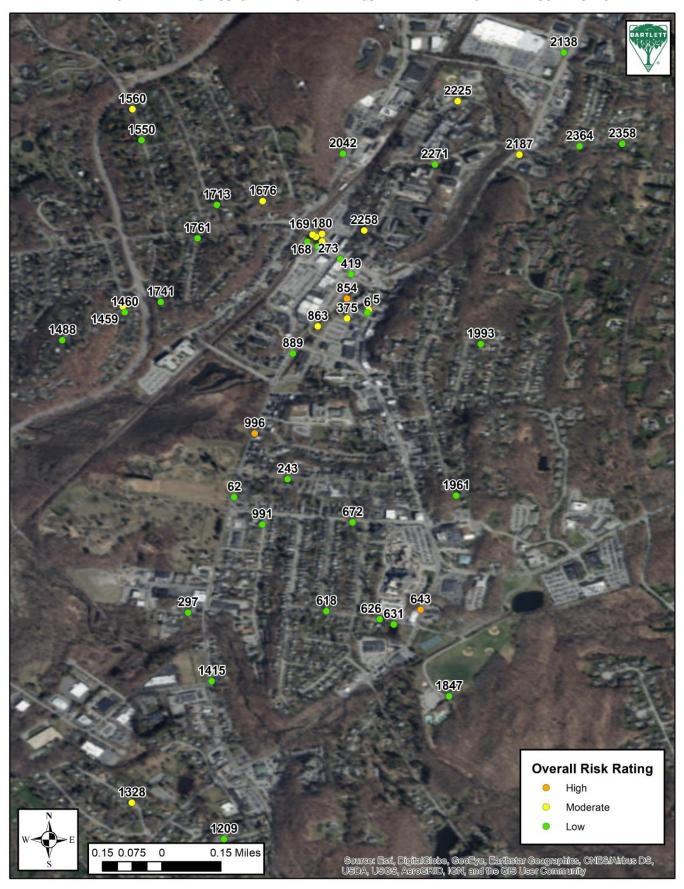
INVENTORIED TREES ASSIGNED RISK RATINGS AT THE TIME OF DATA COLLECTION

Tree ID	Common Name	DBH	Condition	Overall Risk Rating	Primary Target	Tree Care Priority	Advanced Assessment	Pruning	Sunnari	Root Collar Excavation	Defect(s) or Observation(s)
278	Zelkova- Japanese	13	Good	Low	Street	5	• Stem • Root	Raise, Structural		Yes	 Girdling material Growing against object Decay-Root flare Poor branch structure

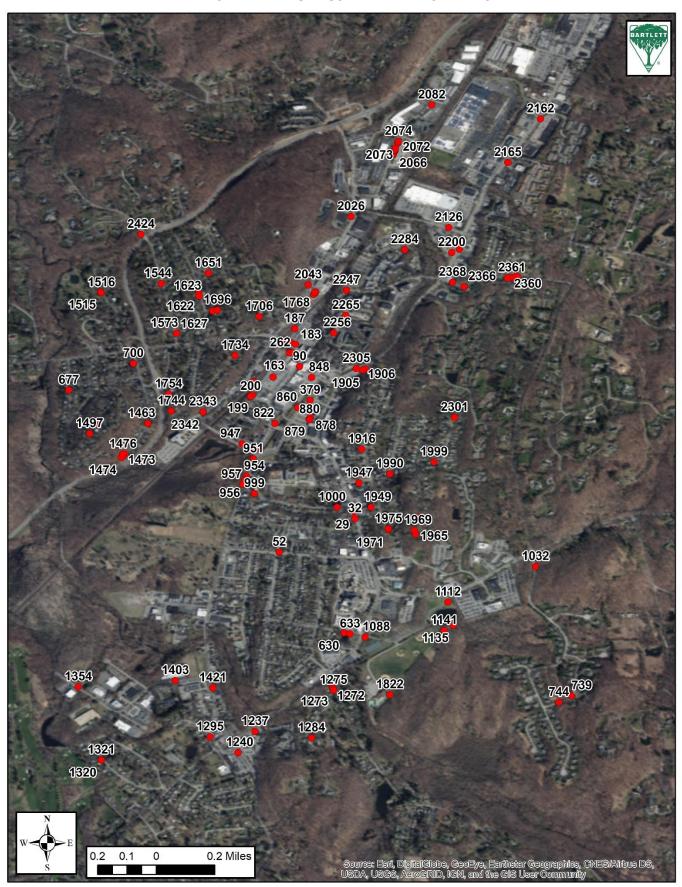
INVENTORIED TREES RECOMMENDED FOR REMOVAL

Remove 156 trees (6%) due to condition or because of their location in relation to other trees to try and prevent competition or damage to infrastructure.
